Simple Lab Analysis Saves Manufacturer More Than \$82,000 Annually

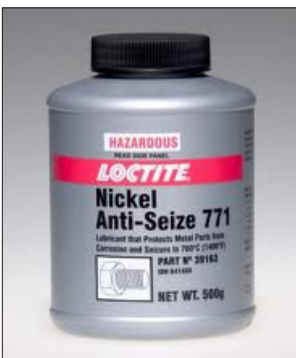
Anxious for a remedy, they asked for our help. After visiting to get the facts and broken bolt samples, we sent the samples to socket screw manufacturer Holo-Krome for lab analysis. HK concluded that the combination of fine threads and use of the wrong anti-seize formula was the cause of the seizures.

We recommended a standard, off the shelf, coarse threaded, Holo-Krome socket screw combined with Loctite #771 anti-seize.

Our customer ran two tests, five weeks apart, using the recommended fasteners and anti-seize. Each time, the fasteners came apart effortlessly.
